# Gualala Watershed Synthesis Report

# Analyses and Results by Subbasin

## *Gualala Basins: Estuary, Northfork, Rockpile, Buckeye, Wheatfield, Main/Southfork*

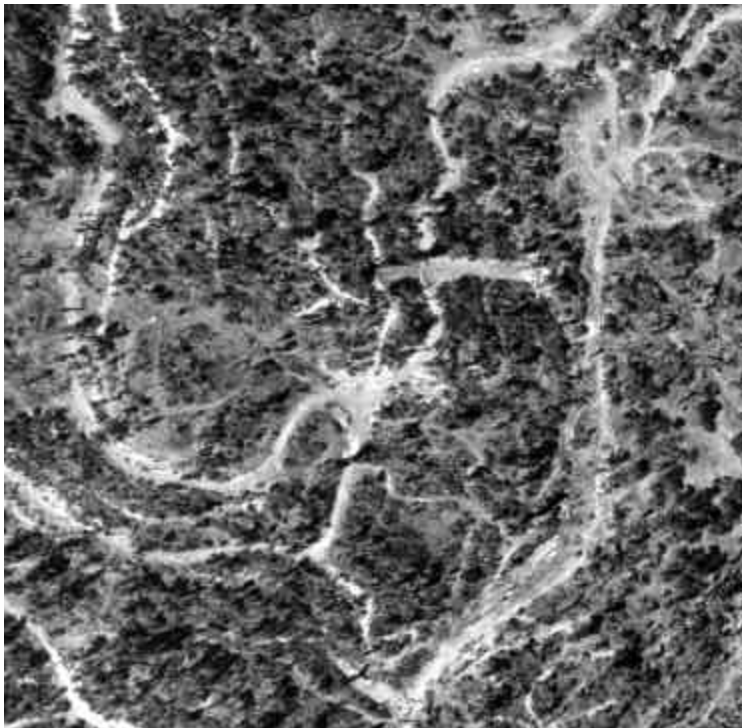
**FIGURE 39: Tobacco Ck. 1964**

Tobacco Ck. incised the in-stream landing (upper left) during the 1964 winter storm surge, creating a canyon on the discharge side (red arrow).

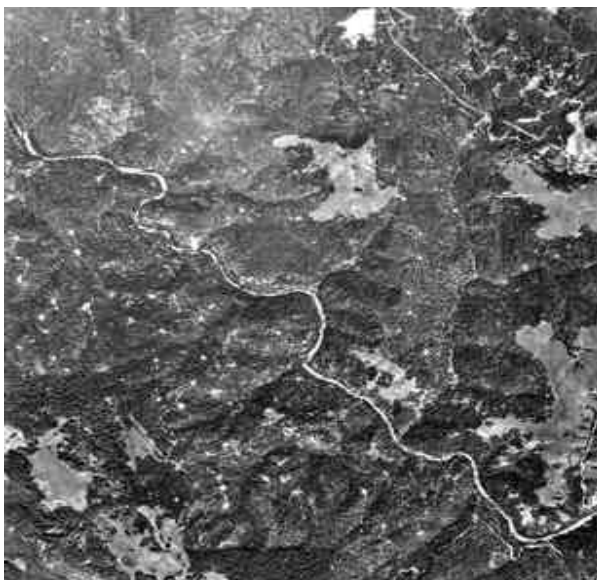
**FIGURE 45: 1984 photo**

1984. Young conifer in-growth reestablished vegetative cover, although storm run-off continues to concentrate along streamside legacy roads and skid trails. Pool infill, shallow pool structure, stream simplification, and increasing embeddedness, impair anadromous fisheries viability. DMG mapped stream channel disturbances in addition to landslide densities using the 1984 aerial photos. Stream surveys show declines of anadromous fisheries.

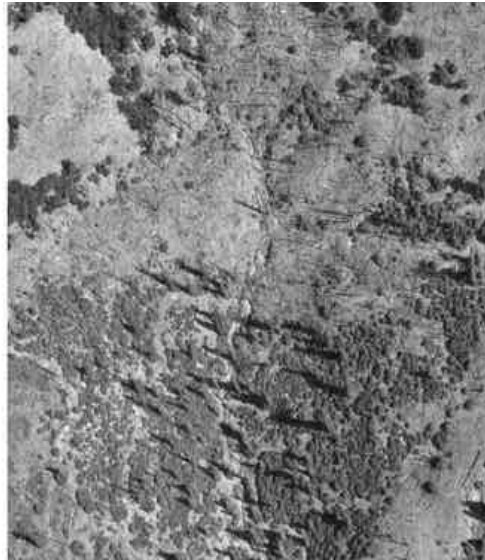
Conversion project removing conifers over the creek, leaving hardwoods upslope.
